June 16, 2015

**MEMORANDUM**

**SUBJECT:** Impromptu visual cap inspection at the San Jacinto River  
Waste Pits superfund site

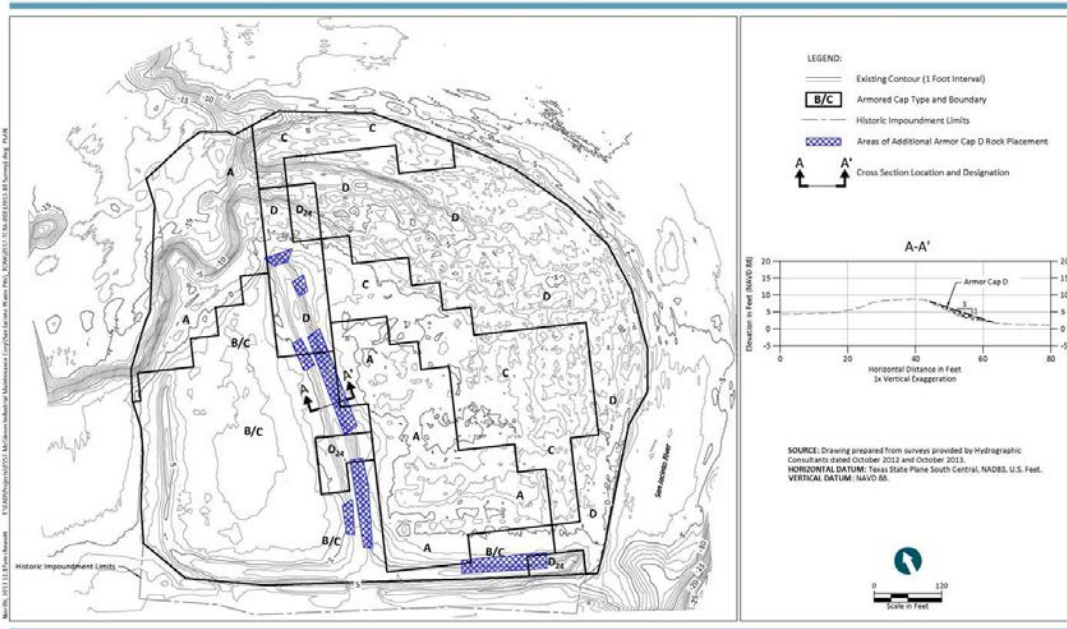
Figure 1  
Armor Cap Repair Plan  
San Jacinto River Waste Pits Superfund Site

In addition to inspecting the overall integrity of the armor cap, seven additional areas (see Figure 1) were inspected where additional rock was placed and the slopes flattened to provide more stability and strength per the enhancement work plan dated November 2013. The section of the armor cap located above water level (western cell) was observed to be intact with no areas of cap erosion evident (see Photo 1-2). It was noted that several small areas of minor cap erosion along the central berm were evident by patches of the geotextile filter fabric exposed (See Photos 3-5).

Figure 1- Areas to be covered with additional rock and flatten slopes from November 2013 Armor Cap Enhancement plan

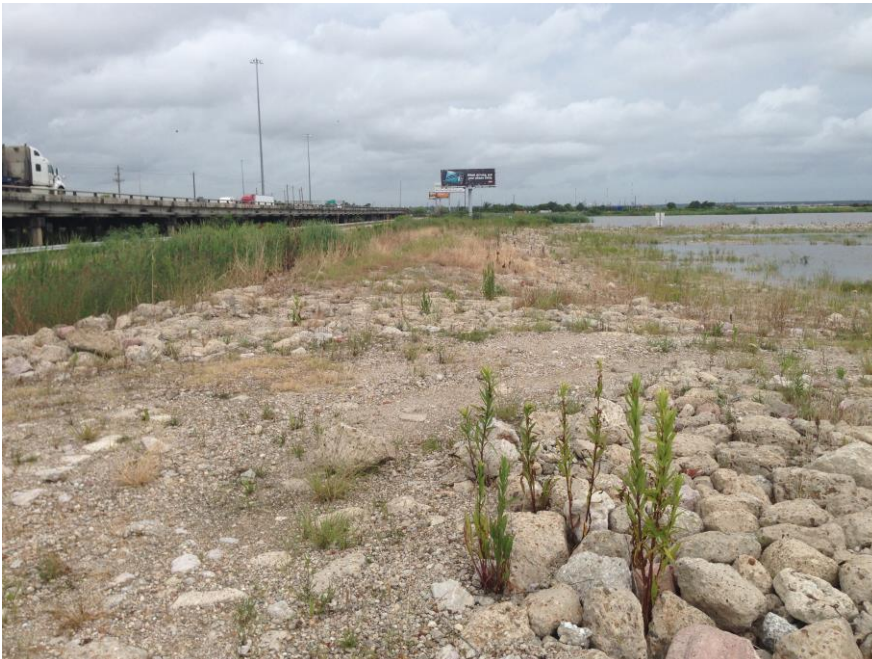
Photo 1- View of southern berm (looking west) and Western Cell surrounded by vegetative growth along San Jacinto River

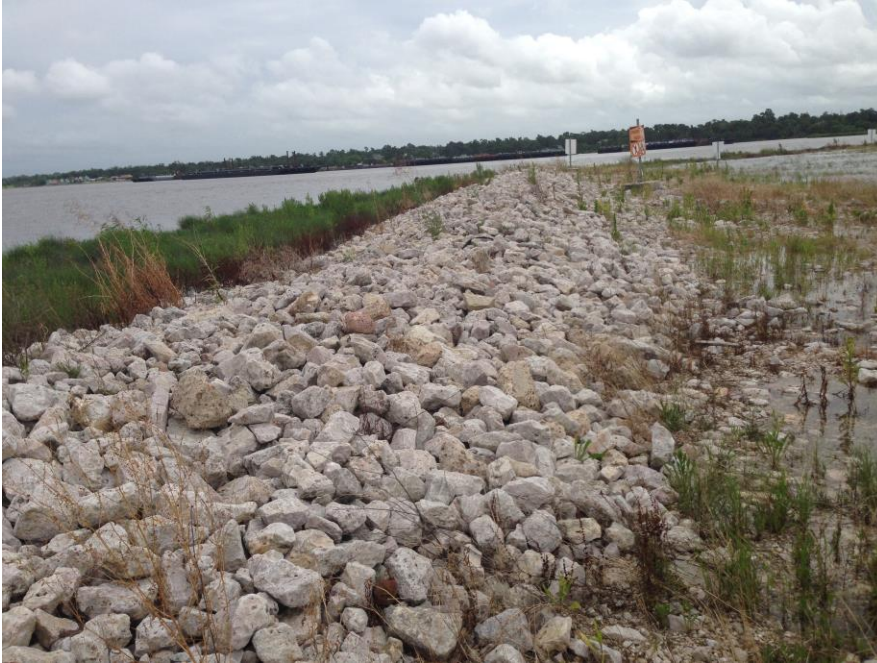
Photo 2- View of western berm along western cell (looking north towards San Jacinto River).

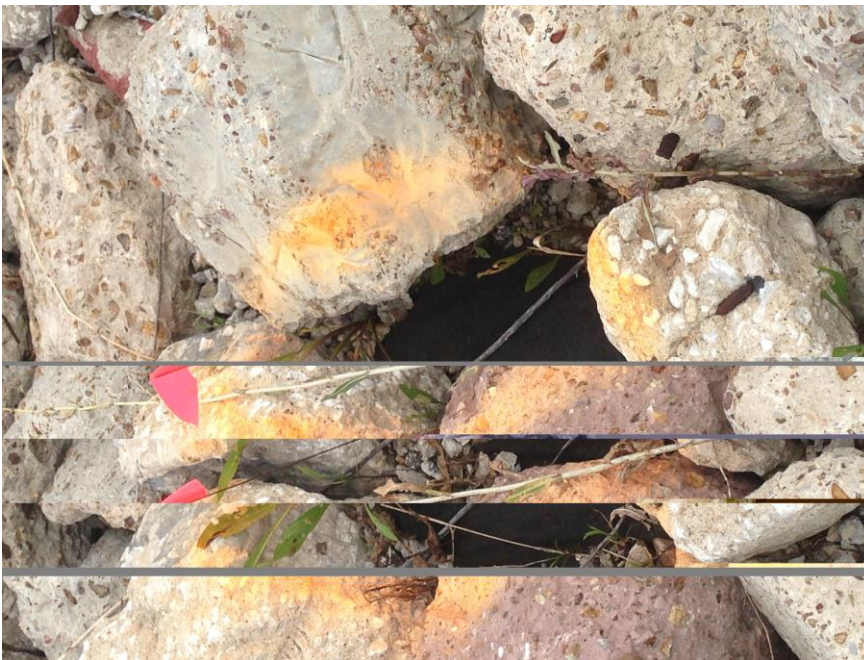
Photo 3- Magnified view of one area along central berm with geotextile fabric exposed

A review of the respondents TCRA monthly monitoring report dated June 15, 2015, have indicated no problematic areas needing cap repair or maintenance. However, due to this most recent visual cap inspection conducted on June 15, 2015, several areas of the armor cap are needing immediate attention. The first item needing immediate attention is the placement of additional armor material along the areas identified in this report, second, an additional application of weed control and maintenance is needed in areas with new vegetative growth, and lastly, a site walkthrough and removal of any vegetative growth that might obstruct site signage along the entire perimeter is needed.

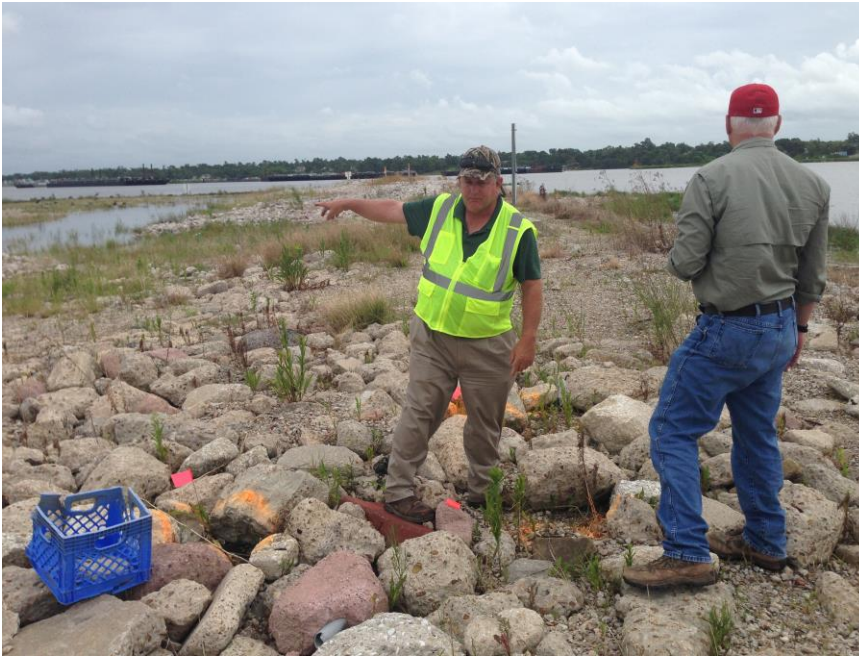
Photo 4- Areas along central berm (noted with orange paint) where geotextile fabric is exposed

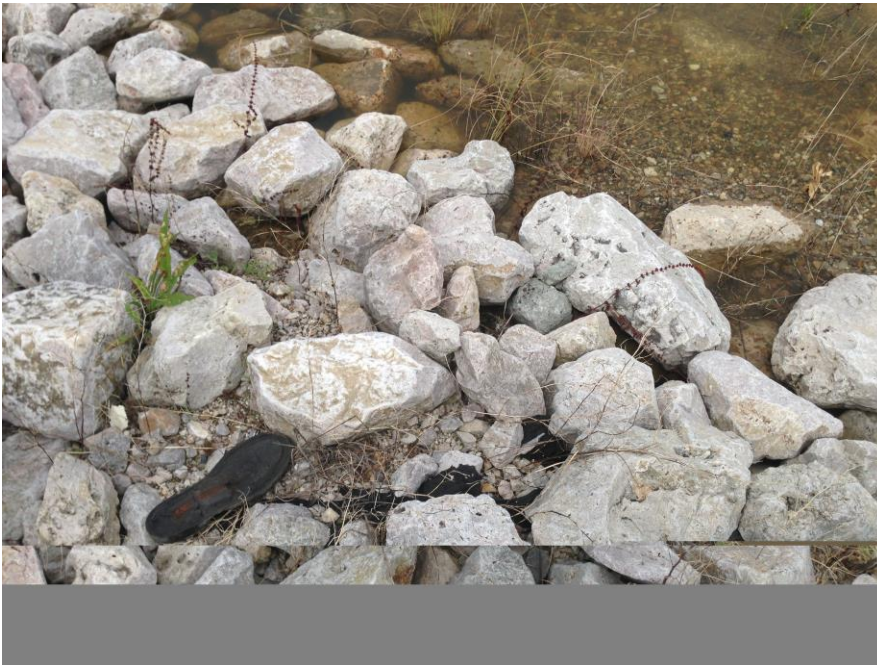
Photo 5- View of small area (note scale with size 10 shoe) where geotextile fabric is exposed which is located along the northern part of central berm and east along eastern berm.

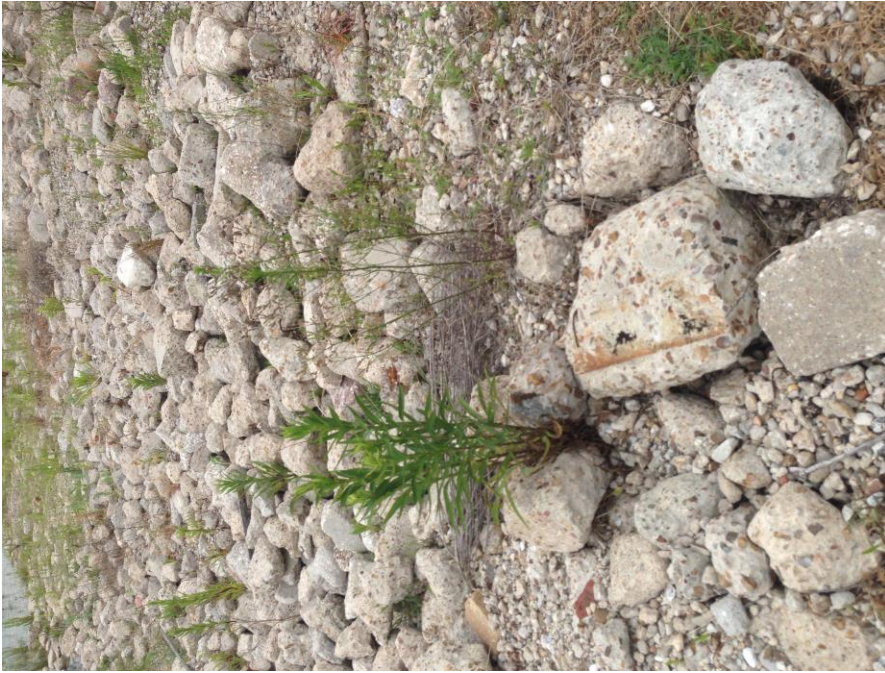
Due to the recent rains and flooding in the area, it was noted that a higher abundance of vegetative growth needing maintenance and control is needed (See Photo 7). It was noted during the cap inspection that prior vegetative maintenance and control was evident due to the brown and dead weeds, however more aggressive treatment and additional applications are warranted due to the increasing appearance of new vegetative growth.

Photo 7- View of vegetative growth along eastern berm.

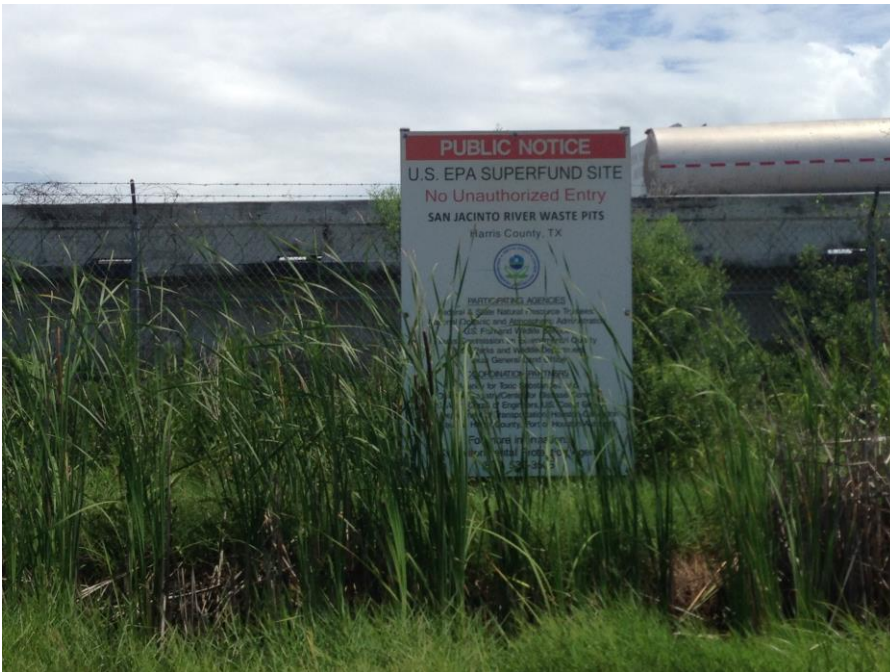
On June 15, 2015, EPA RPM Leos conducted a site visit to document observations at the San Jacinto River Waste Pits superfund site. During the site visit it was noted that the Site security fencing visible and intact. Site signage placed along the fencing perimeter was visible and intact with the exception of the southern gate located south of I10 which has an overgrowth of weeds and shrubs obstructing part of the signage (See Photo 8).

Photo 8- View of vegetative growth obstructing site signage near southern gate south of I10.
